CASE STUDY

Offshore Supply Vessel Delay: Impacts on Scheduling, Efficiency, and Safety.

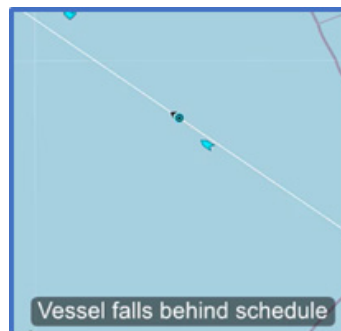
During the journey out to the field the OSV fell behind the planned schedule.

The OSV, for an unknown reason, has fallen behind (11 km) the target plan, as can be seen in Figure 1: The vessel falls behind schedule. For the OSV to meet the target plan, the vessel increases its speed.

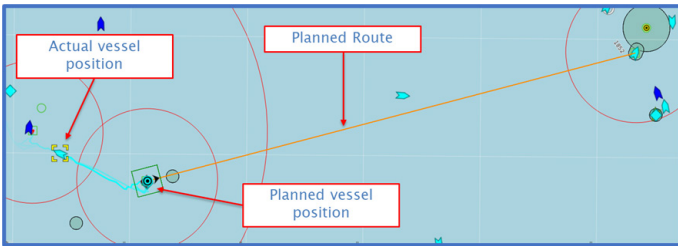
After completing activities at the FPSO, the vessel made an unplanned move to the west. This had a knock-on effect on the next stage of the journey, as it was now 7km off the planned position.

Deviation from planned position

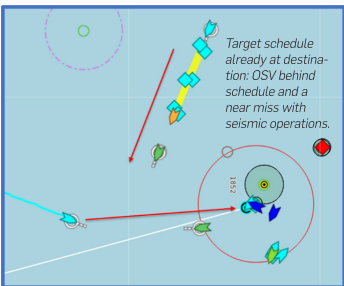
Near-miss with the seismic operations.

To make up time, the vessel increased its speed, which consequently increased overall fuel consumption. Additionally, there were planned seismic survey activities in the vicinity, which had been considered when the route plan was created. The vessel had to increase speed again to pass in

front of the 10-kilometer-long seismic cable spread. Not only did this increase fuel consumption and emissions, but it also increased the potential for accidents.

Safety protocols and regulations should always be followed. The near-miss incident underscores the importance of respecting plans and established guidelines to prevent accidents and injuries. The adoption of a system such as Marlin Application Suite would have alerted all the relevant stakeholders in real-time, and as such, the near-miss could have been avoided.

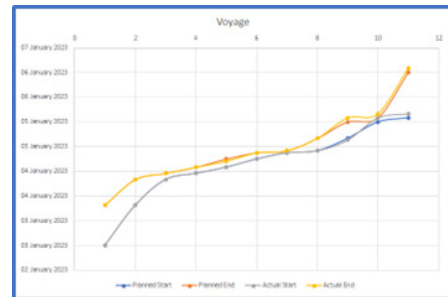
A one-hour delay upon return to the port had a ripple effect throughout the entire supply chain. The subsequent shipping operation, contingent upon the prompt arrival of the OSV's cargo, was pushed back, resulting in financial repercussions for various stakeholders within the supply chain. Despite the dashboard displaying only a 1% overrun on the working time, it fails to reflect the significant knock-on effects of the delay. Figure 5, Planned vs. Actual, offers a granular level of detail into the planned vs. actual data.

Planned vs Actual
